EU Green Week Partner Event

WEFE Nexus Interlinkages of Tsunami-Type Natural Hazards: Case Studies in the Aegean and Marmara Sea, and Baffin Bay

Cevza Melek Kazezyılmaz-Alhan, Kaan İlker Demirezen, Dejana Đorđević,
Dimitris Kofinas, Giannis Adamos, Serena Caucci, Tamara Radjenovic, Stefania
Munaretto, Floor Brower, Chrysi Laspidou

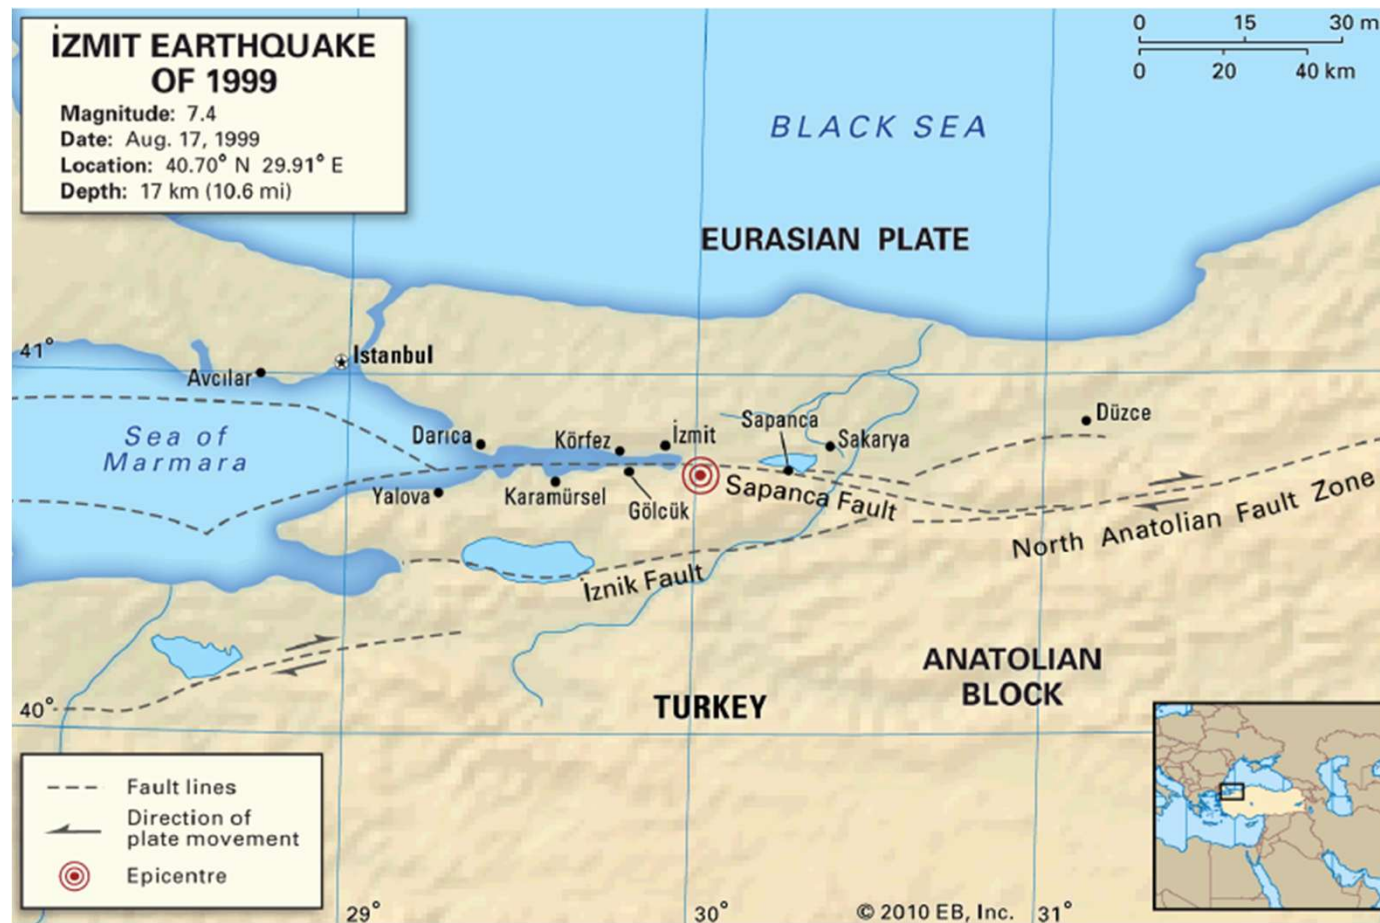
İzmit Tsunami, 1999

- Date and Time: 17 August 1999
- Location: Marmara Sea
İzmit (Türkiye)
- Reason: *Earthquake and submarine landslide*
- Magnitude (Mw): 7.4
- Run-up Height: 2.6 - 2.9 m
- Inundation: 200 - 300 m
- Loss and damage: Unknown; damaged infrastructure: roads, ports, costs, buildings, cars, yachts.

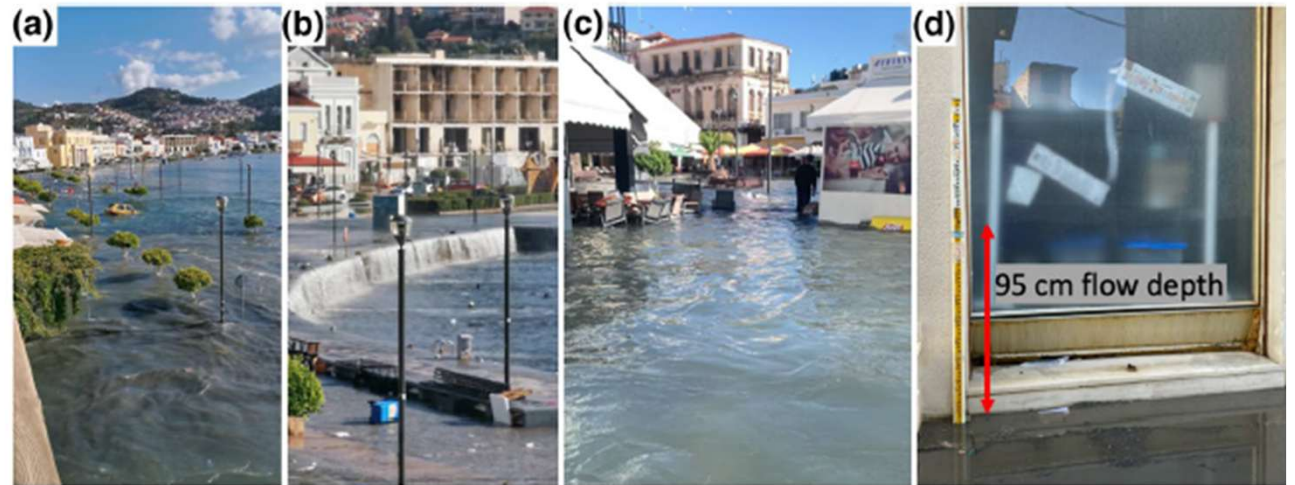
Kalligeris, N, et al. (2021)

- Date: 30 October 2020
- Location: Aegean Sea
Offshore İzmir Province (Türkiye)
Samos Island (Greece)
- Reason: *Earthquake*
- Magnitude (M_w): 7.0
- Run-up Height: 3.8 m
- Inundation: 2490 m (in Alaçatı, Türkiye)
- Loss and damage: 1 life; damaged infrastructure: coasts, yacht marines, roads, houses, cars, yachts.
